GRANT COUNTY, WASH.

Specialized Crane

Repairs Dam

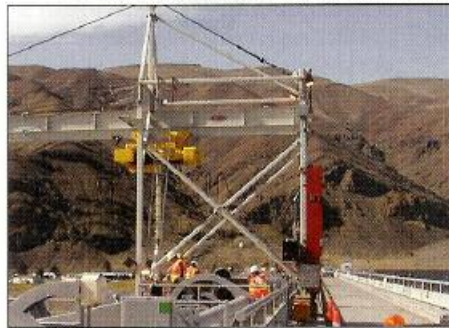
When inspectors discovered cracked thrust washers in the trunnion assemblies of Priest Rapids Dam in eastern Washington, they realized that each corroded assembly from the 22 spillway gates would need to be rehabilitated, and the bronze alloy materials would need to be replaced. (The dam provides flood control and fish passage through spillway gates into the Columbia River).

The company designed and manufactured a five-ton, four-legged, radio-controlled crane to travel up and down the spillway using electric-over-hydraulic power and reposition at each gate. The project required a versatile crane, explains Wood, that we could "strategically place it at different points and still accommodate traffic that uses the roadway across the dam"

As Wheco extracted each of the trunnion assemblies, it transported them to its repair shop for disassembly and component replacement. After the corrosion resistant materials and components were re-assembled and the trunnion materials rehabilitated, the 700-pound assemblies were trucked back to the dam for replacement.
